DAM INSPECTION CHECKLIST POSSUM POINT POWER STATION POND ABC

INSPECTION DATE: 5/5/15

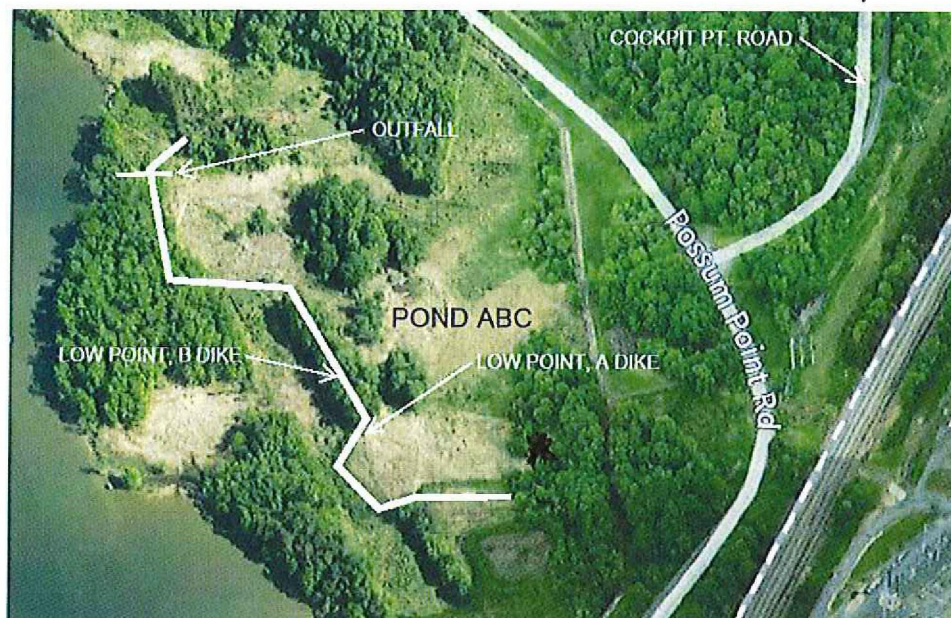
Location/ Condition	(y/n)	Change (y/n)	Comments
Low Point, A dike*			
Flow	N	N	0852 hrs. Standing water along perimeter of pond
Erosion	N	N	new road. Standing water behind sandbags. Very slow seeping in front of sandbags.
Low Point, B dike*			
Flow	N	N	0857 hrs. No standing water. Sand bags and
Erosion	N	N	rip rap in place.
Outfall			
water surface El. (top of stoplogs to water)			0901 hrs. Standing water behind sand bagged area and behind concrete weir structure. 41 1/2". Slow seeping and dripping below 2X10, about 7' down. Standing stagnant water at discharge pipe. Does not appear to be discharging.

Additional Comments (Note any changes observed along the embankment crest or downstream slope observed from the crest.): No rainfall event in last 72 hrs. * Standing water and wet at NE end of A pond, (area indicated by *). Standing water at the base of the slope between A & B pond.
